Trip Report #2

12th Street Landfill Site

Wilmington, New Castle Co., DE

12 May 2000

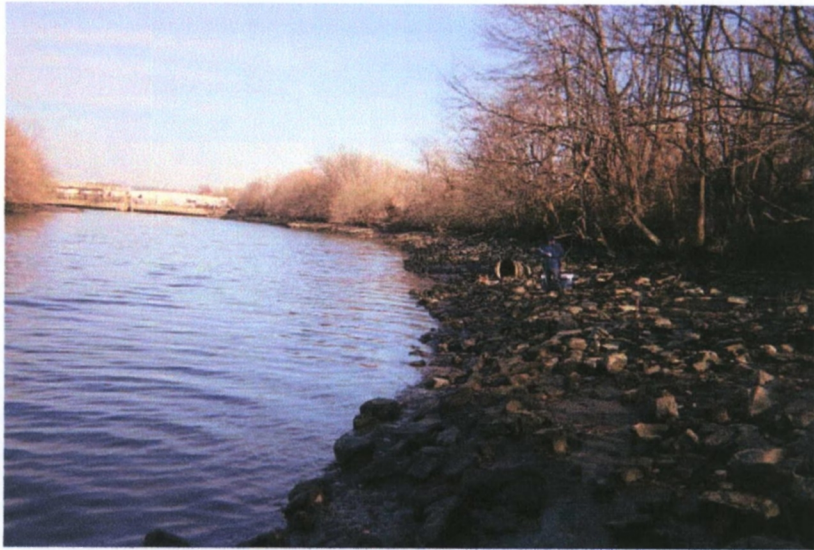
Description: Brandywine Creek mudflat during low tide facing north.
SATA member is preparing to ^{collect a} sample the sediment ^{sample.}

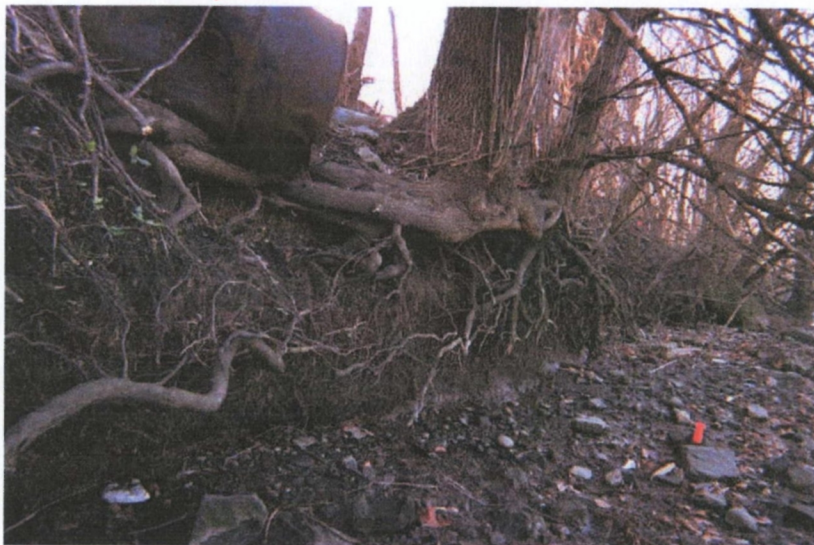
Description: Brandywine Creek bank with exposed drums in view.

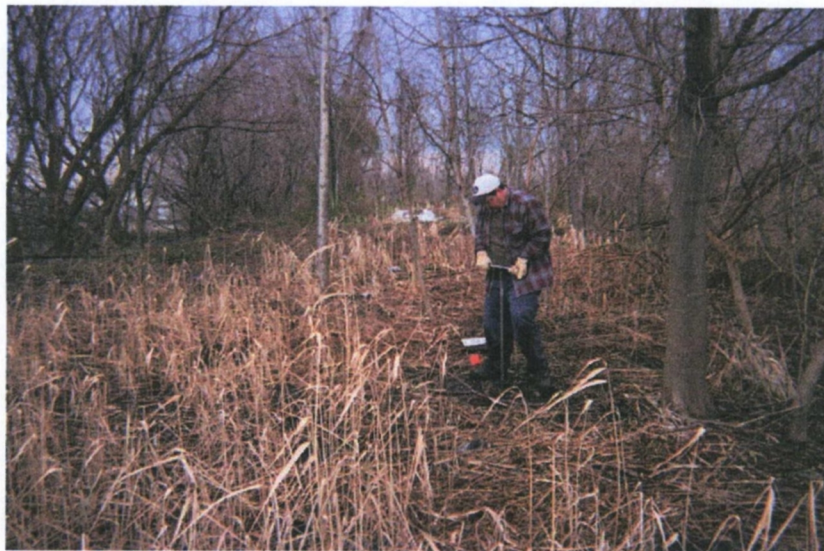
Date Taken: 12 January 2000
 Photographer: *SE* Region III SATA
 Description: Subsurface soil sampling with hand auger.

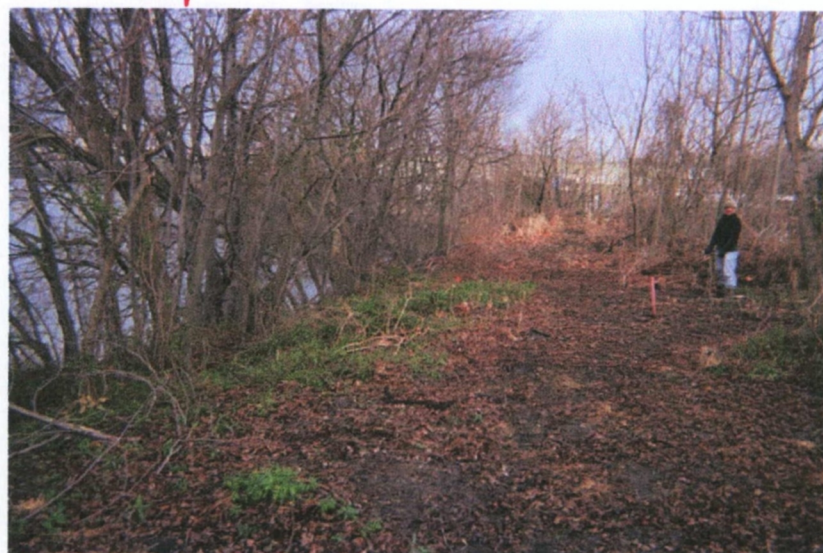
Date Taken: 12 January 2000
 Photographer: Region III SATA
 Description: River bank in the Area of Concern, facing north.
